Geological Mapping of Dam Abutments Utilizing Historic Images and Digital Feature Matching

Gary Robertson
GRAI Imaging Inc. Nepean, Ontario Canada
Doug Bennett
U.S. Department of the Interior
Bureau of Reclamation

Keywords: Geological Mapping, Dip and Strike, Historical Images, Dam Abutment, digital image matching.

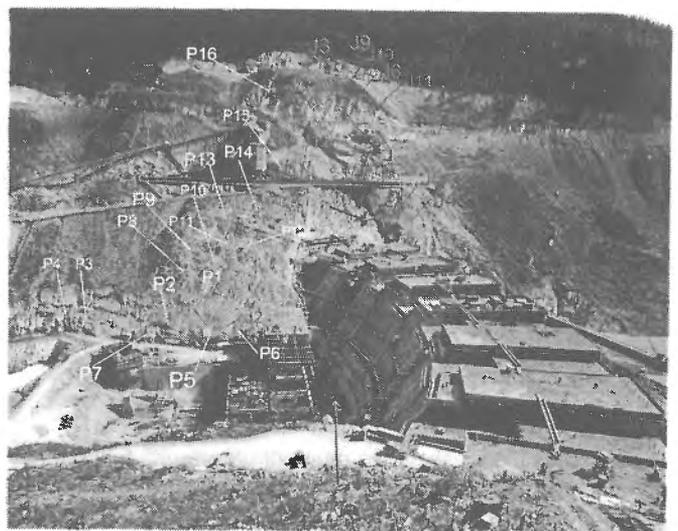
Figure 9 Location of Data Sets

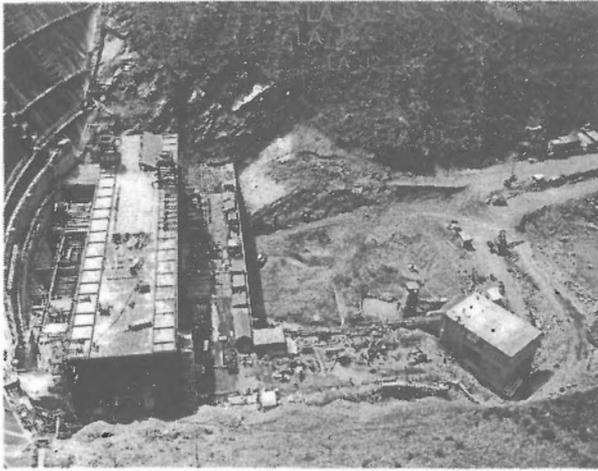
Figure 10 Location of Data Sets
