DOCUMENTATION OF DESTROYED PARTS OF MONUMENTS USING LOW COST RECTIFICATION TECHNIQUES

Georgios P. Antoniou

KEY WORDS: Dodona, Ancient Castle, Ancient theater, Ancient tower, Amorgos, Orthorectification

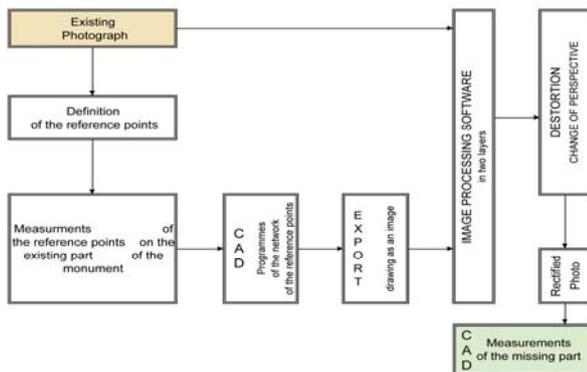
Figure 1. Flow chart of the major methodology

These points which are the guides for the rectification are drawn in a CAD application and afterwards are exported as an image file, preferably Jpeg or Tiff. That image is inserted along with the photograph under rectification in image processing software. There, the original image is distorted, scaled etc so the equivalent points coincide with the drawn ones. The more the reference points are, the greater the accuracy will be.

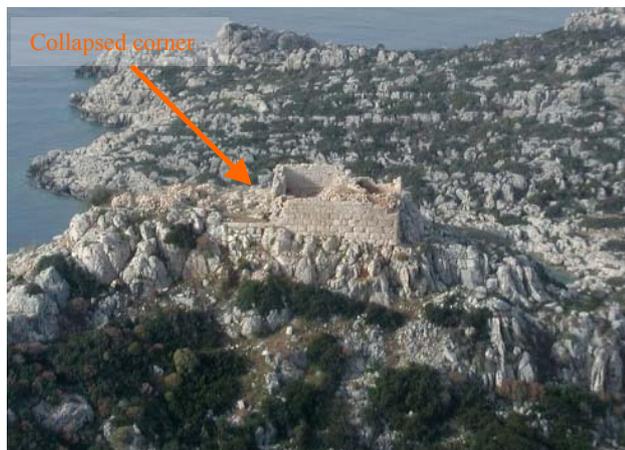
Figure 2. Aerial view of the ancient fortress. © G. P. Antoniou

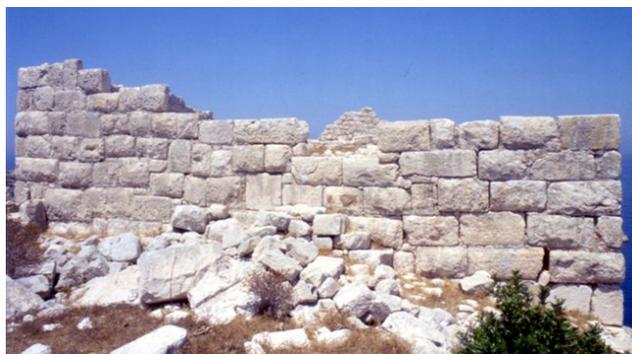
Figure 3. Photograph of the east facade before the collapse of the northeast corner (KB' EPKA)

Many measurements on site provided an accurate network of the regulated masonry joints from the existing part not only on the north wall but also on the eastern one. That network was used for the rectification of the photograph. The picture was inserted in a CAD application. The precision of $\pm 5\text{cm}$ acquired was adequate to determine the dimensions of the missing stone blocks after the drawn elevation of the whole north face of the fortress.

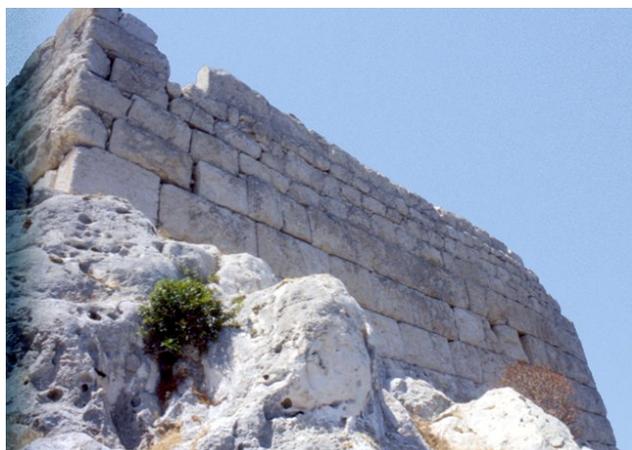
Figure 4. The north facade before the collapse. (KB' EPKA)

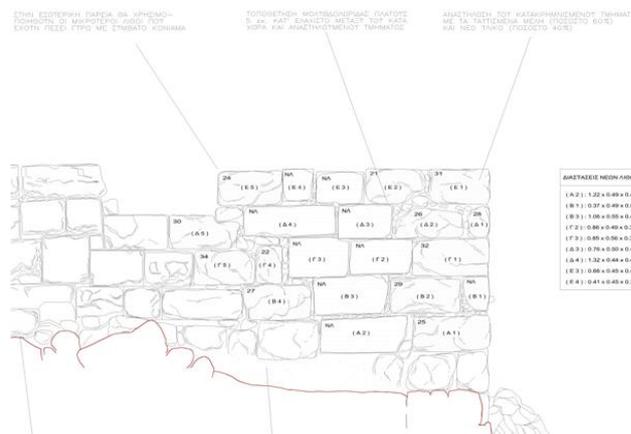
Figure 5. East elevation with the identified stoneblocks (shade)

According to these listed dimensions, 80% of the collapsed stones were found on the slope and their original position was identified. (Fig. 5) The project was approved by the C. A. C. and has already been partially applied.

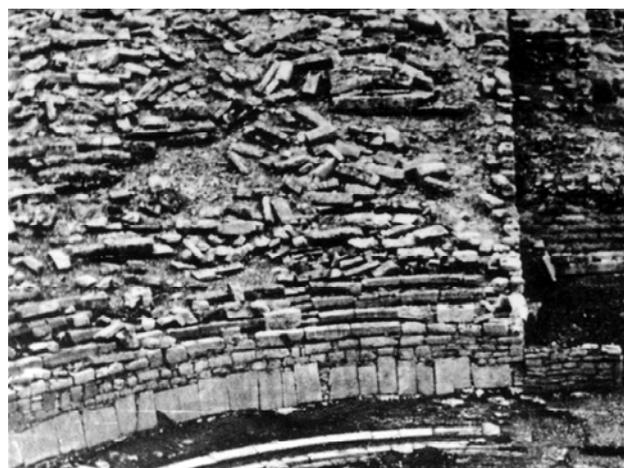
Figure 6. View of seat tier 1, Zone A before the intervention of 1960

A part of the study for the Restoration of the Ancient Theater required the identification of the numerous seats and parts of the cave which were misspositioned during the intervention made in 1960, without any previous documentation. Such identification of the original position of many parts was possible using some simple general view photos, taken before that intervention and the detailed documentation of the cave made by the photogrammetry experts of our team. Because of the curved layout of the cave, the method was applied with multiple partial rectifications of the most suitable photograph. (Fig. 6)

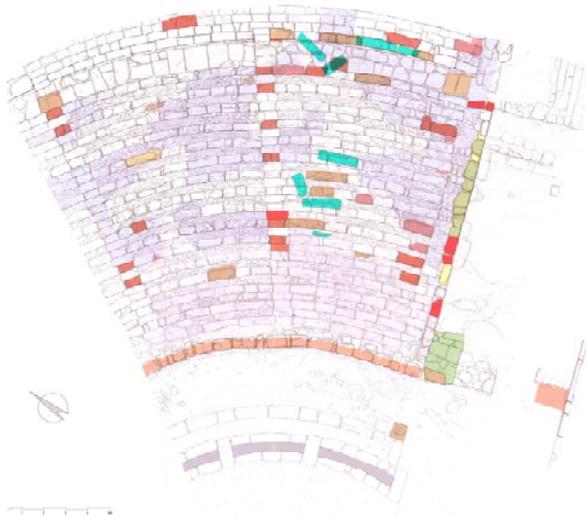
Figure 7. Edolia with their position before 1960 testified (blue)

The detailed measurements supported the data from the photogrammetric products. Some of these results have already been embodied at the Study for the Restoration of the Ancient Theatre of Dodona. (Αντωνίου, 2005) In this case it is possible to identify in which position are today most of the edolia of the seat tiers K1A and K2A, visible in that image taken before the intervention of 1960.

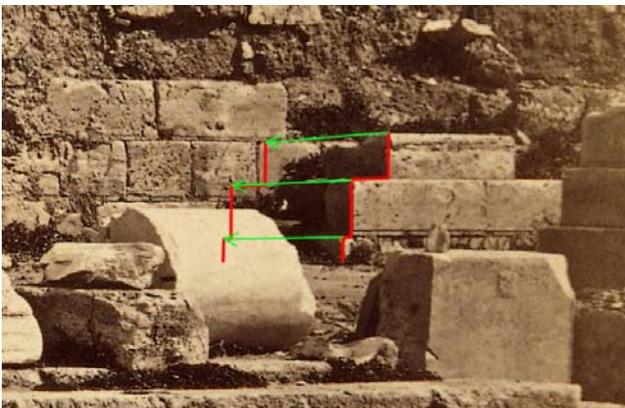
Figure 8. The historic photo with the projection of the base on the wall

The base, which does not exist any more, is shown in an historic photograph of the 2nd half of 19th century, illustrating just the west part of it. The base is consisted of 2 steps plus the foundation stone which was originally protruding out of the ground. (Fig. 8)

In the historic photograph all the pieces are illustrated clearly. At the background of the base, it is visible part of the retaining wall of the east parodos of Dionysus theatre in Athens. All that part of the wall survives today and could be recorded in details.

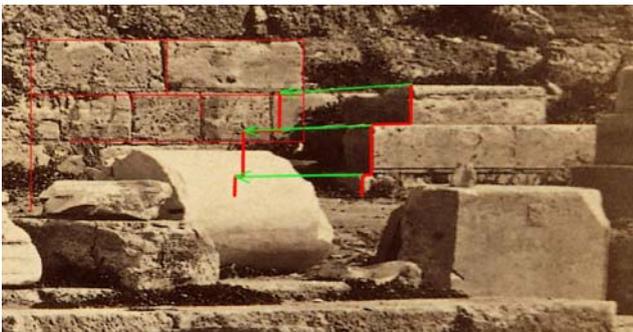
Figure 9. The rectified photo with the projection of the outline of the base.

According to the methodology of that case the outline of the base was projected and marked on the wall. Afterwards the photograph with the marked outline was rectified using as reference the measured grid of the masonry of the retaining wall (Fig. 9). At the end, in the same CAD application, the elevation of the monumental base was drawn in its original dimensions (Fig.10)

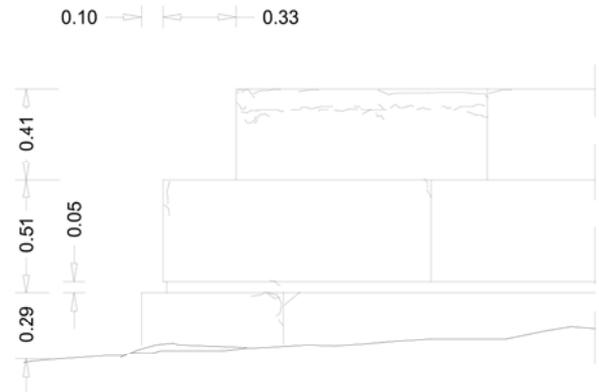
Figure 10. Front elevation of the base in its original dimensions

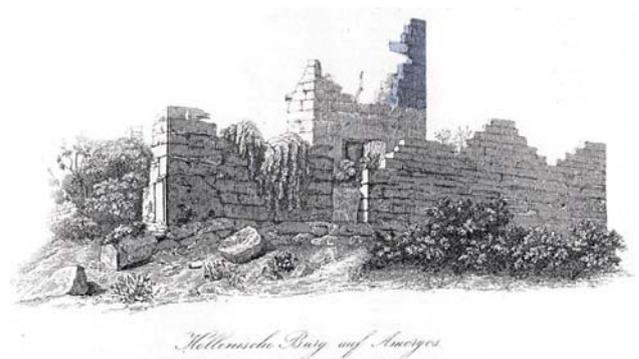
Figure 11. The engraving of L. Ross, 1843 (Ross, 1843)

The engraving of Ludvich Ross, published in 1843, shows the tower of Ag. Triada on Amorgos, from the southeast -outside the yard. Among other parts which survived then much higher than today, is the northeast corner of the central tower. That corner collapsed later on and the stoneblocks fell in the yard where they were recorded in details by the author in 2003, (Fig. 12) after a commission by KB Ephorate of Classical Antiquities for the study of the removal of the stones and other small scale interventions in the yard.

The engraving was classified as a very detailed one and many of the illustrated parts in it were indisputable identified on the monument today. Therefore it was practiced experimentally the process for the identification of the original position of the stoneblocks of the collapsed corner. The rectification of the engraving using the methodology of case 3.1, resulted in the ability for dimensioning of these stones, as they appear up in their original position. Using those dimensions many of the

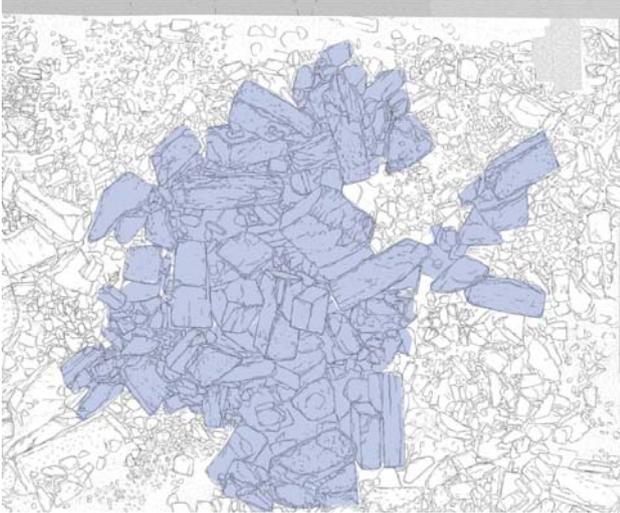
Figure 12. The stoneblocks of the NE corner of the tower after their collapse.
