PROTECTION OF NATURAL CATCHMENT AREAS SUPPLYING WATER TO ISTANBUL AND MONITORING ILLEGAL CONSTRUCTION WITH PERIODICALLY COLLECTED IKONOS IMAGERY

KEY WORDS: Satellite, IKONOS, Change Detection, Illegal Construction, Catchment Area

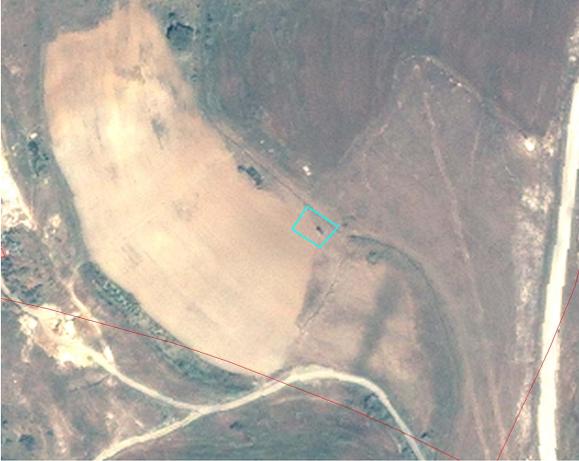
Figure 1. IKONOS Imagery before Construction

Secondary step in the ISKI Office is the change detection analysis made by the operators comparing the newly collected imagery and the imagery of 3 months before. The analysis is made in all the zones of the 7 catchment areas. A geodatabase is created for the change detection data and updated every period.

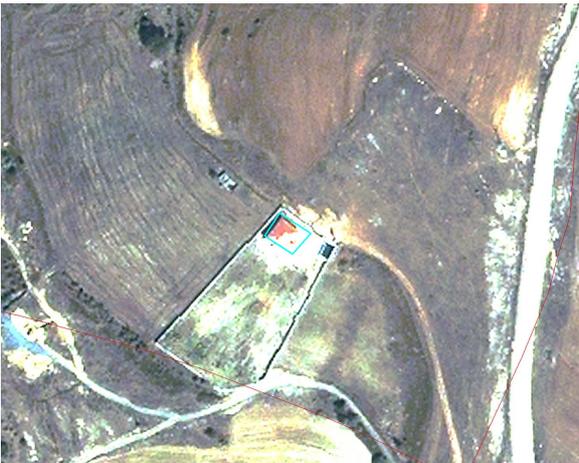
Figure 1. IKONOS Imagery after Construction
