MYANMAR: A COMPARISON BETWEEN PAST AND PRESENT. WHAT IS HAPPENING IN THE FIELD OF ARCHITECTURAL HERITAGE CONSERVATION: THE TECHNIQUES USED, THE PRINCIPLES OF PRESERVATION APPLIED AND THE RELATIVE PLANS FOR HERITAGE MANAGEMENT

Beatrice Messeri^a

KEY WORDS: architecture, cultural heritage, comparison, management, database, planning, authenticity, Myanmar

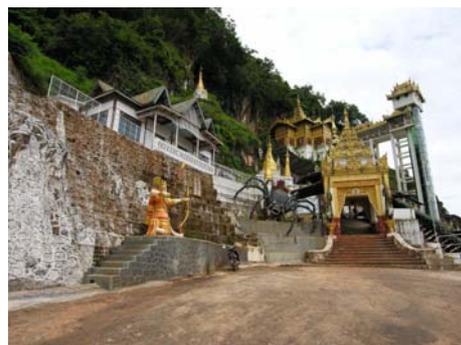
Figure 2. Pindaya caves

The spreading of the Disney style is not circumscribed to the case of Bagan alone; the Pindaya Caves (Figure 2) are another emblematic example. The Pindaya caves are carved out of a limestone ridge overlooking the Pindaya lake and are characterised by the presence of thousands of Buddha images made from alabaster, teak, marble, brick, lacquer and cement which have been placed there in the course of time since the 11th century and arranged in such a way as to form a labyrinth throughout the various cave chambers. In accordance with a local legend, the modern access to the caves has been achieved with statues of deplorable taste, and above an imposing structure in reinforced concrete and glass with adjoining lift disfigures the surrounding landscape. The interior continues to be evocative, but in this case too it has seen the addition of a staircase in ceramic tiling, which has likewise been used for the flooring inside the cave. Unfortunately not all the Buddha statues still enjoy their original colouring or at least part of it, in fact quite recently they have been repainted or in certain cases fresh gilding has been applied.

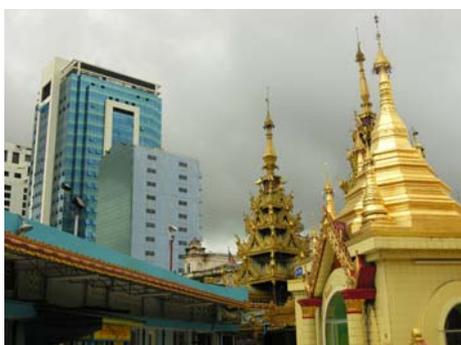
Figure 3. Yangon, The Sule Pagoda and the buildings

Another great scandal arose with the construction of gigantic skyscrapers that overlook and constitute an eyesore to the area surrounding one of the most important monuments of the country, the Sule Pagoda in Yangon (Figure 3). The Pagoda is said to have been built more than 2000 years ago, but has undergone multiple restorations and renovations since then. The contrast between the contemporary and the ancient architecture is very marked, indeed the overpowering of the temple by the new buildings is total, thus also diminishing its symbolic importance.

In addition new architectural modifications have been carried out which have substantially changed its external appearance with the inclusion of new rooms against the perimeter of the building, also more magnificent entrances have been made at the main points of the compass. The style partially picks up in its design that of the typical architecture, creating undoubted contrasts with that already existing. Whereas one of the symbols of the country, the Shwedagon Pagoda (Figure 4), is another emblematic example of architecture. Little is known about the foundation of the monument, probably in the XIV century when from a small pavilion a pagoda of larger dimensions was created, but almost certainly the work of greatest entity was carried out in the XV century under Shinsawbu (1453-1472), founder of the new dynasty of Hanthawaddy (Moore E., Mayer H., Win Pe U, 1999).

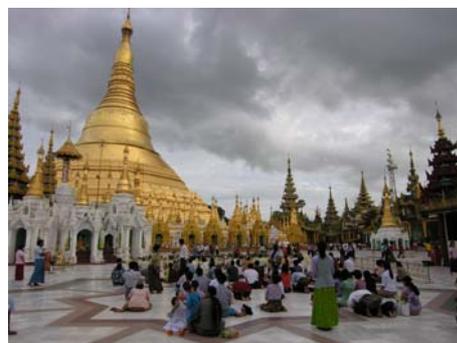
Figure 4. Yangon, The Shwedagon Pagoda

In the course of the centuries the structure of the Shwedagon Pagoda was damaged by a series of earthquakes of which that

of June 1768 proved particularly serious, and it was precisely on this occasion that one of the biggest tasks of reconstruction was undertaken. In 1824 the British troops established their headquarters in the Pagoda, because of its strategic position in the country, and it was only in February 1826, with the end of the war, that the troops evacuated the Shwedagon. Following this episode and after the subsequent invasions by British troops in 1852 and in 1885 quite serious damages were inflicted, which made it necessary to reinstate certain fundamental parts.

The restoration works took place in 1929, nearly 80 years after it was last occupied and on 2 March 1930 a ceremony took place with the celebration of the re-opening of the Western Stairway for public use. Unfortunately only one year after this episode, one of the temporary structures set up for the ceremony caught fire and spread to many other parts of the temple complex which were burnt down, above all some of the most beautiful buildings erected between the XIX and the XX century. The subsequent reconstruction of the buildings was slow and in any case the previous quality of the architecture was not achieved. The next great period of building activity ran from the late 1980s to the 1990s. The State Law and the Order Restoration Council encouraged the arts and on this occasion many works were undertaken with the construction of the Museum, the Library and the Archives and renovation of the stairways (Chain U Tun Aung, Hlaing U Thein, 1996). The Shwedagon Pagoda in Yangon was completely restored, the gold re-painted with gold or gilded in some parts and the flooring was replaced by a new one. Very often the roofs of the monuments were repainted in gold, if not covered uninterruptedly in very fine gold leaf as prescribed by tradition. The southern entrance has changed in appearance, having been enlarged over the years, as may be noted from the historic photographs of the place, probably in response to the growing requirements of being able to accommodate an ever larger number of tourists above all religious, coming from all over the country. The timber structures are those which have undergone the most replacements, first of all with masonry structures, whereas later cement got the upper hand, so that in the latest interventions carried out the use of this material has irreversibly transformed the structure of the building. Moreover, the town-planning changes in the city and the building of new roads and new buildings have substantially altered the relationship of the monument with the context in which it was set. Polemics on the area surrounding the Pagoda are still open, there is talk of creating a protected zone where buildings more than six storeys high are not supposed to be built. A project for a building of twenty-one storeys has been transformed in accordance with the guidelines of the local authorities to nine storeys, because it was situated to the west of the pagoda, and in its close vicinity.

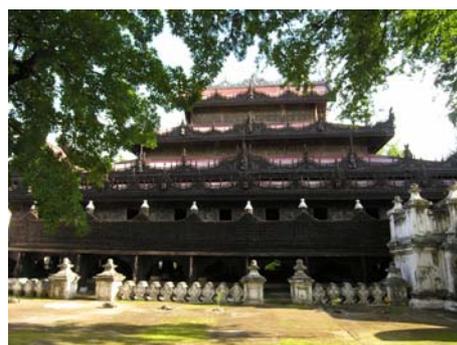
Figure 5. Mandalay, Shwenandaaw Kyaung

distinguished, depending on two different typologies: the era of great temple building in Bagan (1044-1287) and those relative to the Konbaung kings (1752-1885). Undoubtedly the monasteries occupy an important place, and some of these even if under the protection of The Archaeological Survey, in actual fact have not received the attention they deserve over time, indeed all maintenance expenses have continued to be met by the monks. Unfortunately during the Second World War many monasteries were burned down, including the Konbaung royal monasteries, so just only Shwenandaaw Kyaung in Mandalay (Figure 5) has remained standing until today. The latter was reconstructed in its present shapes in 1878-1883 (Fraser Lu S., 2001). The monastery consists of a central hall (35 m by 21 m) and other secondary ones around it and is sustained on a platform of 2 metres by as many as 150 teak pillars. The building, inside is almost completely gilded and adorned with glass mosaic and both inside and outside is finely decorated with examples of woodcarvings, partially replaced in recent times. There are traces of some localised interventions of restoration, such for example as some reinforcement rings around the columns and fortunately, in this case, no attempt has been made to undertake works of indiscriminate gilding as elsewhere, even if certain traces demonstrate their presence both inside, where today it clearly remains still, and outside. For the outside, it would be desirable above all to envisage maintenance work which, together with other works, would foresee the conservation of what is still left.

Following the devastating earthquake of 1975, which hit above all the Bagan area, UNESCO drew up a conservation project in the early 1980s which in any case succeeded in drawing attention to the timber structures. In 1983, Jacques Dumarçay, an expert on South-East Asia, was entrusted with drawing up an inventory of timber monasteries worthy of preservation, twenty-three such monuments were indicated and the most urgent measures to be taken on these by teams of expert carpenters coming under the dependencies of the Department of Archaeology were programmed (Fraser Lu S., 2001). Many of these buildings were first of all dismantled, then restored, then re-assembled on concrete blocks to stabilise the structure and create a barrier against termites, or at the very least many were anchored to concrete foundations like the monastery Shwenandaaw Kyaung itself in Mandalay (restoration dated 1996).

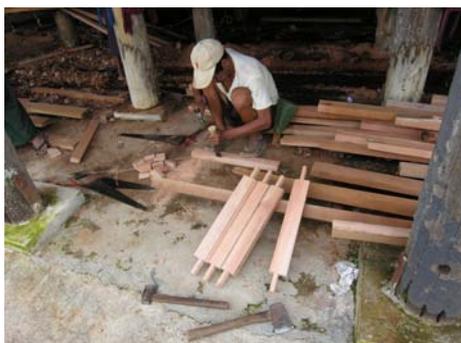
Figure 6. Renovation works at Shwei Yan Pye Kyaung

The inclusion of new technologies in these edifices creates quite marked contrasts, indeed the fact that the technological systems are mainly carried out in an improvised way often disfigures the existing part, as for example in the splendid monastery Shwei Yan Pye Kyaung (Yaung kwe district, Shan State), dating from 1888. The building has been undergoing renovations since 1998 with the addition of important structural parts. There are a number of cases such as that of the monastery Nga He Chaung (Lake Inle, dating back to 1843) where the majesty, the complexity and the beauty of the structure clash with a policy of conservation liable to criticism; in fact major substitutions may be noted, such as that of the typical roofing by sheet metal, thus bearing witness to a quite widespread practice both in the field of civil and of religious architecture.
