# INVESTIGATING THE INFLUENCE OF IONIZING RADIATION ON STANDARD CCD CAMERAS AND A POSSIBLE IMPACT ON PHOTOGRAMMETRIC MEASUREMENTS

A. Marbs\*, F. Boochs

i3mainz - Institute for Spatial Information and Surveying Technology,  
FH Mainz - University of Applied Sciences,  
Holzstr. 36, 55116 Mainz, Germany  
(marbs, boochs)@geoinform.fh-mainz.de

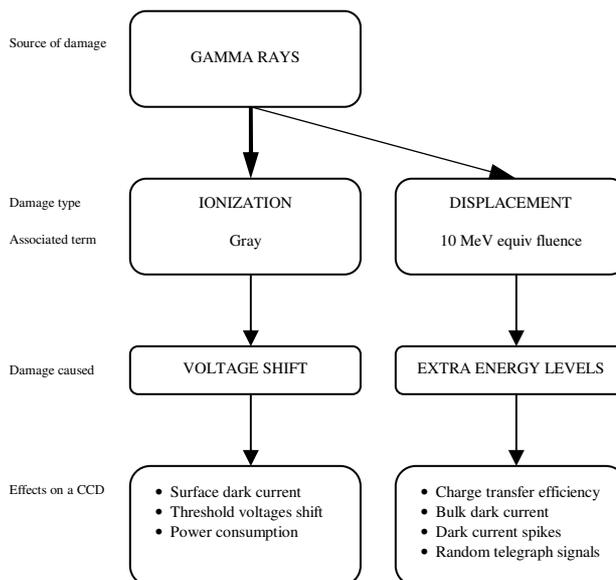
Figure 1. The radiation damage tree for CCDs. Illustration from (Bassler, 2004)

Figure 1 shows what type of damage will be produced by gamma rays onto a CCD. The main effect is ionization, resulting in voltage shifts on the surface of the silicon which

leads to increased dark current and noise. If the energy level is high enough (> 10 MeV) this can even cause displacement of Si atoms and leads to permanent hot pixels or even to sensor malfunction.

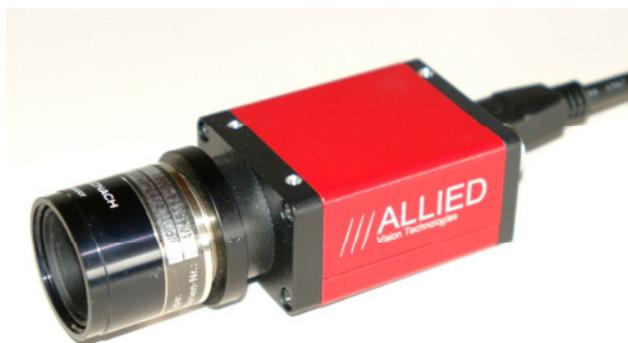
Figure 2. Test camera

For the radiation tests an industrial CCD color camera AVT Marlin F-145C2 was used. See Table 1 for specifications. Marlin cameras are often used in photogrammetric applications and represent a typical imaging device possibly being used for the later alignment task, although higher resolution will be likely.

AVT Marlin F-145C2 (color)	
Image device	1/2" type progressive scan SONY IT CCD
Image format	1280 x 960
Pixel size	4.65 $\mu\text{m}$ x 4.65 $\mu\text{m}$
Resolution depth	8 bit
Lens mount	C-Mount
Digital Interface	IEEE 1394
Dimensions	58 mm x 44 mm x 29 mm (w/o lens)

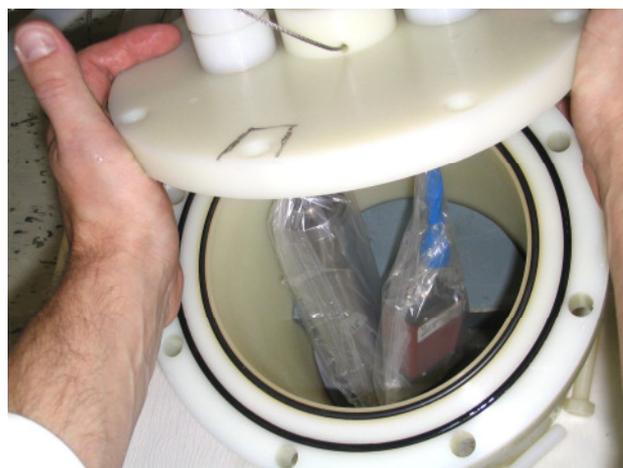
Figure 3. Polyethylene container which carries camera and radiation sensor.

Then the reactor was started for a few minutes, depending on the desired gamma level. After shut down, the camera was put into a small polyethylene container and lowered down to the reactor core (see figures 3 and 4). Depending on the position of the container, different dose rates could be achieved. The dose rate was measured with a radiation sensor which was also arranged in the PE container. With this setup dose rate of up to 100 mSv/h could be tested.

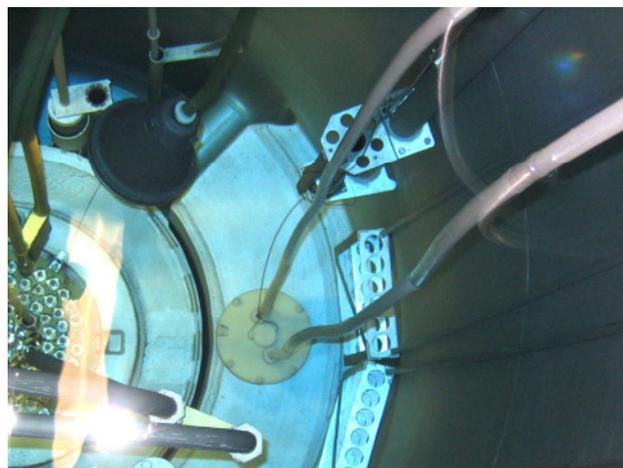
Figure 4. Top view of the reactor core with PE container. A 6 m water column protects people against radiation.

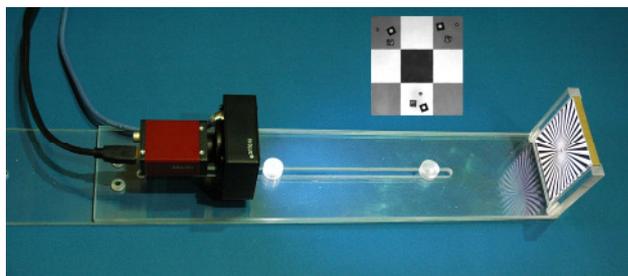
Figure 5. Plexiglas mount with camera, ring lighting and Siemens star target. The small image in the middle shows the second pattern with different colored areas and photogrammetric targets.

For the second test series a different setup had to be chosen since it was not possible to take images within the PE container. For this purpose a “thermal column” was used, a 1261 mm long and 100 mm x 100 mm wide slot which penetrates the concrete shielding and ends close to the reactor core. With the help of a Plexiglas construction, the camera, an LED ring light, a target and a radiation sensor were mounted on a carrier (Fig. 5). Depending on the position within the thermal column different dose rates were realized. However, in contrast to the measurements in the PE container, only dose rates up to 8 mSv/h were possible due to safety reasons.

Two different targets were used. A Siemens star served as a device to test the resolution or possible changes of resolution

during irradiation, respectively. A second plate contains both photogrammetric targets to test the image measurement accuracy and different colored surfaces (white, grey, black) to investigate noise and hot pixels.

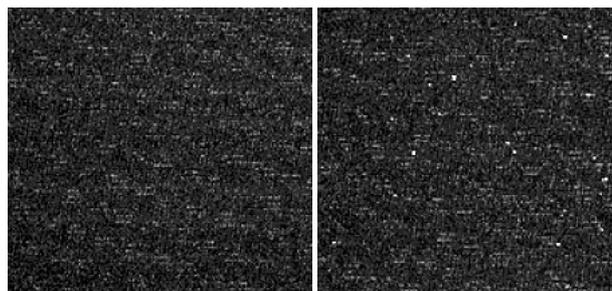
Figure 6. Section from images without radiation (left) and with 100 mSv/h gamma radiation (right). Histograms are stretched to make "hot pixels" visible.

In total 59 images were taken in two sessions at the dark exposure setup. Different settings of gain (0 to 450) and shutter time (0 to 4095 ms) were used for exposure. Table 2 shows an extract from the resulting protocol. Since the change of the mean gray value was too small to measure reliably (it was 0.00 in all images taken with gain 0), the columns "standard deviation", "maximum gray value" and "number of gray values larger than 0" are more meaningful. There is a significant correlation between dose rate and these values. Looking at the histograms of the images confirms, that there is a slight increase of noise in the images as well as an increase of the number of hot pixels. Looking at Fig. 6 clearly shows a significant amount of hot pixels in the right image. For a better presentation the image histograms have been stretched, hence pixels appearing to be white have gray values lower than 40 in reality. At dose rates of only 10 mSv/h, which amounts to one tenth of the dose rate of the right image of Fig. 6 and equals to the expected dose rates at FAIR, almost no hot pixels could be detected.
